**Eccentric cam on tensioner pulley fractures during tensioning process.  
Timing belt kits CT1168K1/ K2/ WP1/ WP2/ WP7/ WP9/ K6PRO/ WP8PRO  
VW, Audi, Seat, Skoda 1.4–2.0 TDI common rail, EA288**

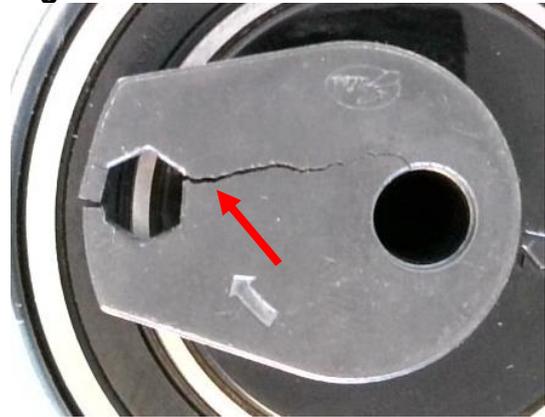
**Fig. A**

Adjustment cam on tensioner pulley fractures during tensioning process (**Fig. A**).

The fastening nut is overtightened during assembly. As a result of this, the nut turns together with the adjustment cam during tensioning, subjecting it to an even greater load. This produces too much resistance, causing the eccentric cam to crack (**Fig. A**).
