NEW PRODUCT HIGHLIGHT | OCT2021

febi 175857

Oil Pan with oil drain plug and seal ring

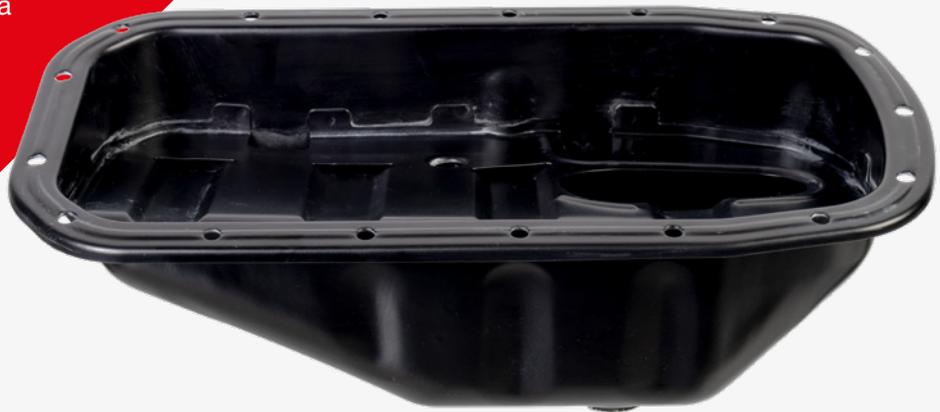
The oil pan is attached to the base of the engine block and serves as the reservoir for the engine oil - before and after it has been pumped around the engine. It also assists with the cooling of the engine oil.

A windage tray and internal baffles are also fitted to the inside of the sump. This is to help slow down the sideways movement of the oil as the vehicle travels through the twists and turns of the road; ensuring the oil is in the correct place for the oil pump strainer tube. This extends into the lowest part of the sump to give a constant supply of oil to the oil pump.

Stones and other road debris damage the painted surface of the oil pan, allowing moisture to corrode the steel. As the corroded area increases, the steel becomes porous, which will be seen as a film of oil. This is the start of an oil leak. If the corroded oil pan is not replaced, engine oil will continue to be lost. Over time, as the corroded oil pan weakens, the oil leak increases - eventually causing a loss of oil pressure and the potential for catastrophic engine damage, as well as potential danger to the environment and other road users.

It is recommended that when replacing oil pan 175857, oil pan gasket 21157 is also replaced - along with a replacement of the engine oil and filter.
