Discs with ABS Rings

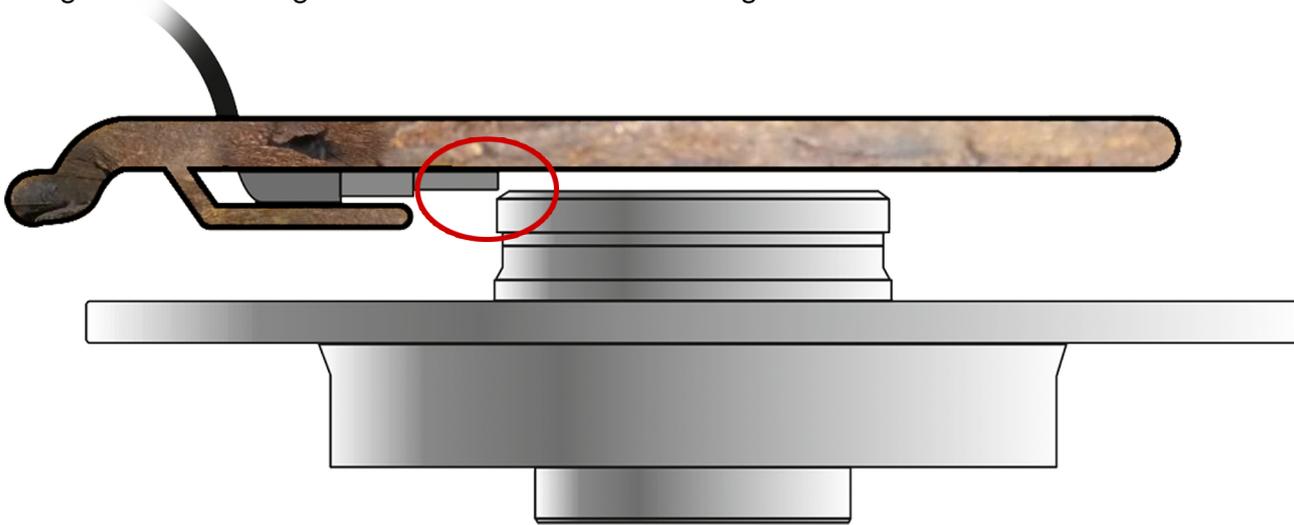
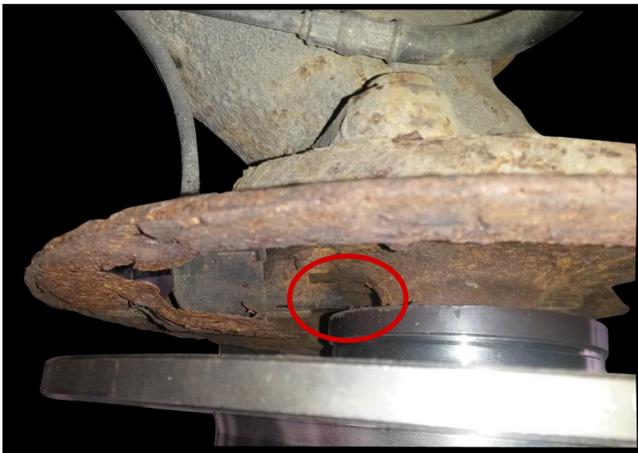
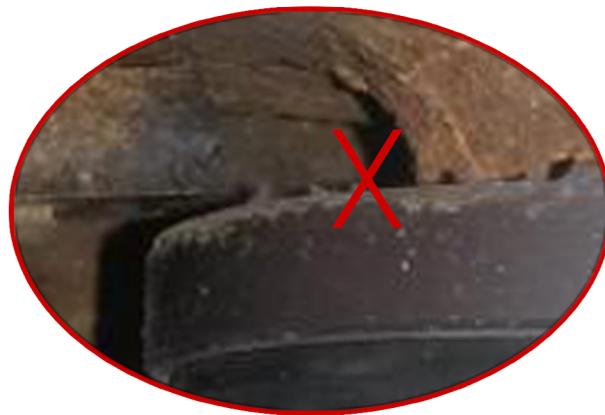
Problem: When changing brake discs that have an ABS sensor fitted, the disc can at times touch the ABS sensor, and if the disc is pushed all the way in it may bend the sensor and the magnetic sensor ring on the disc can become damaged.

Solution: The ABS sensor is being forced away from its correct position by the rust build up behind it on the dust cover plate.

It is advised to remove the sensor and clean away the corrosion. However if the corrosion is too severe it may be necessary to fit a new dust cover plate.
