LuK Service Info

Part Nr. 230 0022 11 – 280/295mm TGU6

Manufacturer: STEYR

Model: 80 SERIES

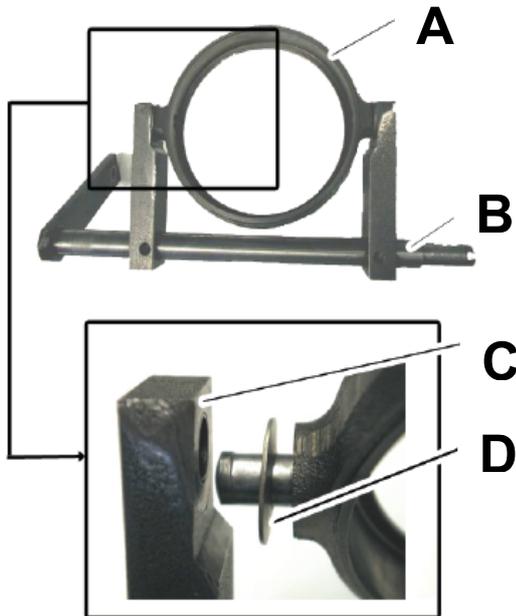
- A - Release bearing carrier**
- B - Actuation shaft**
- C - Release fork arm**
- D - Thrust washer**

Excessive or uneven wear to the release bearing carrier pivots can result in failure or breakage of the PTO release bearing. Prolonged use in this condition can damage the PTO clutch release plate and levers. Uneven release movement of the clutch pressure plates causes noise and vibration. All areas of wear need to be addressed when replacing the clutch assembly.
