# OIL PUMP FOR 1.8 & 2.0 TFSI ENGINES

OIL PUMPS | 11402

X-Ref: 06H 115 105 FK

**V10-4899**

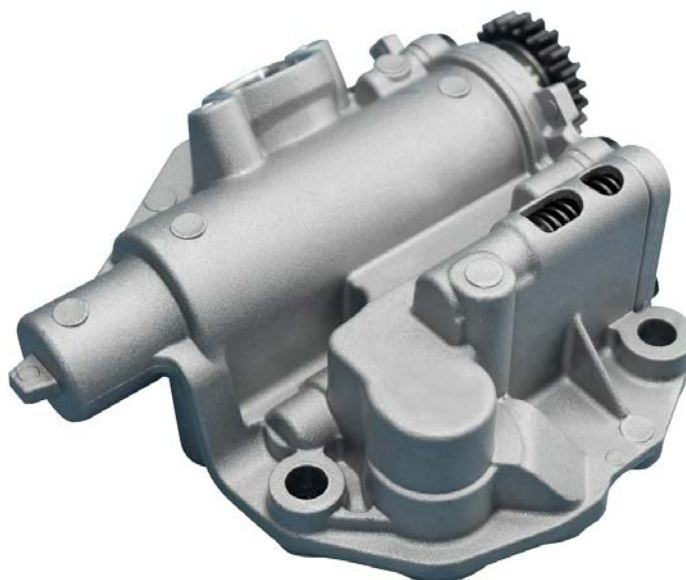
In all common combustion engines, the oil pump ensures sufficient oil pressure and thus the lubrication of all moving components of the unit. However, the oil pumps in Volkswagen's TFSI engines are particularly susceptible to damage. If the vehicle has not been moved for a long time at low temperatures, clicking noises may come from the engine compartment when the engine is started or shortly afterwards, indicating the defective oil pump. In this case, it is advisable to replace the oil pump as soon as possible to prevent consequential damage to other components.

- Clicking noise from the engine compartment after starting the engine

- Increased wear due to insufficient oil pressure
- Engine damage

- Vehicle is parked for a long time in low ambient temperatures
- Faulty oil pump

- Renew oil pump
