4.4 Secondary air system

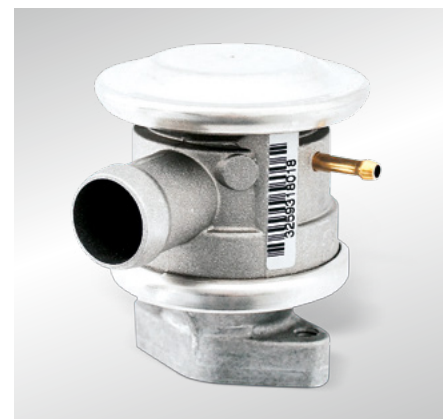
Cut-off secondary air valves are opened only while secondary air is being blown in immediately after cold start.

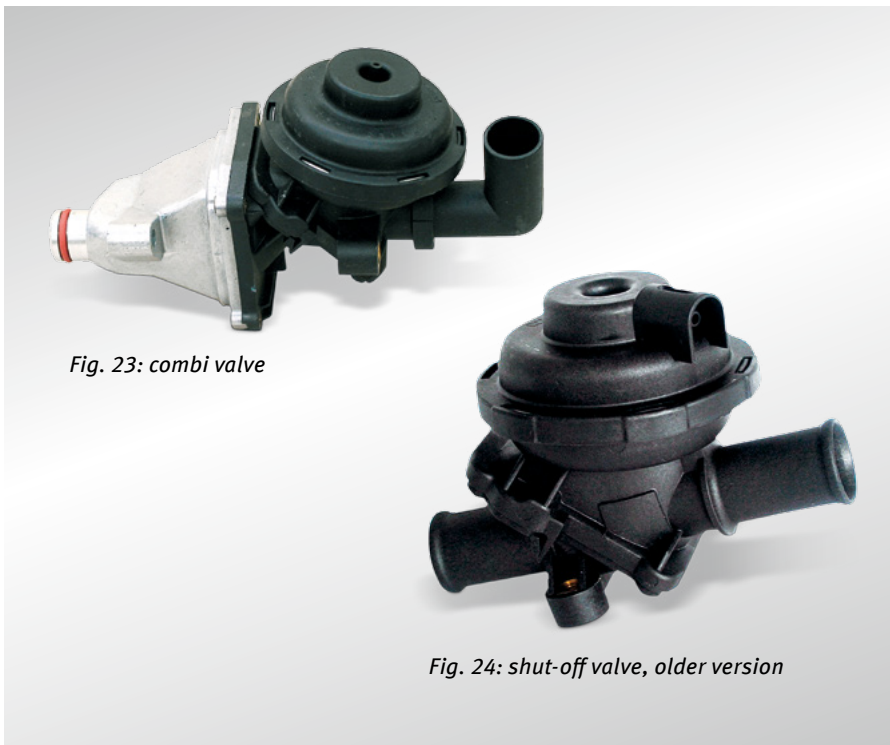
Fig. 23: combi valve

Combi valves consist of a shut-off valve with a built-in non-return valve.

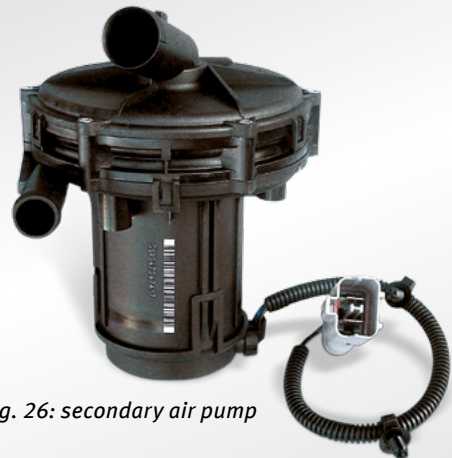
Fig. 26: secondary air pump

Secondary air pumps are high-speed one or two-stage fans.

If the air is not extracted from the inlet port but directly from the engine compartment, an air filter is integrated.

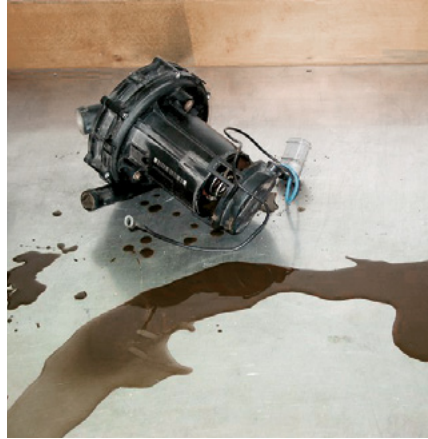
Fig. 28: condensate in the secondary air pump

A frequently occurring error is a malfunctioning secondary air pump. Almost always damage is caused by exhaust gas condensates in the pump.

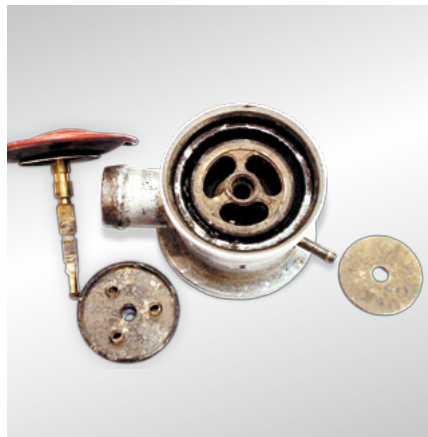
Fig. 30: cut-off secondary air valve – damage to the diaphragm and valve plate due to condensates
